SCREENING SITE INSPECTION REPORT

YPSILANTI TOWNSHIP LANDFILL

YPSILANTI, MICHIGAN

April 29, 1991

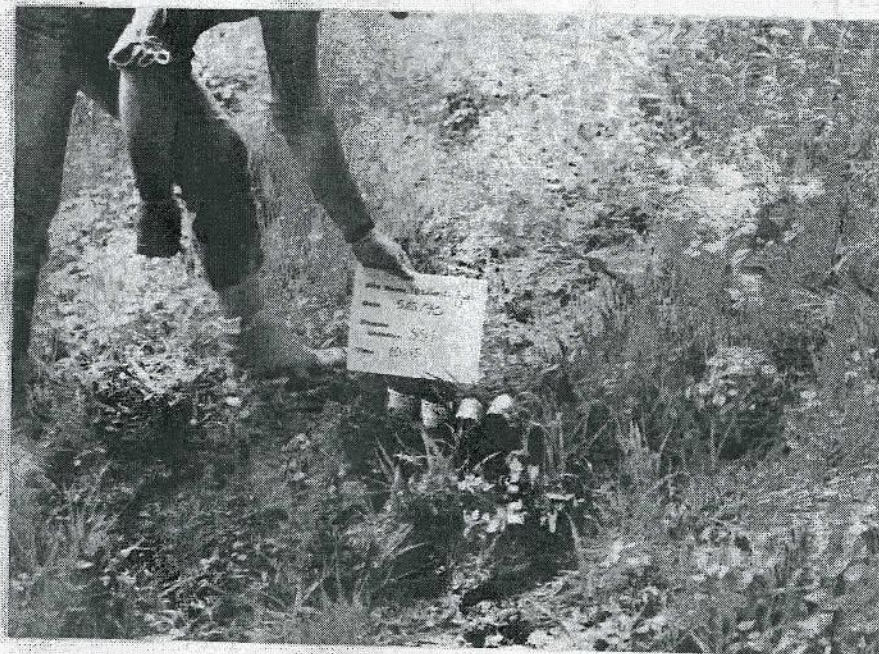
> SS1 (B)

DESCRIPTION: > Background soil sample; from yard across  
> Spring Avenue north of site (1 ft depth)

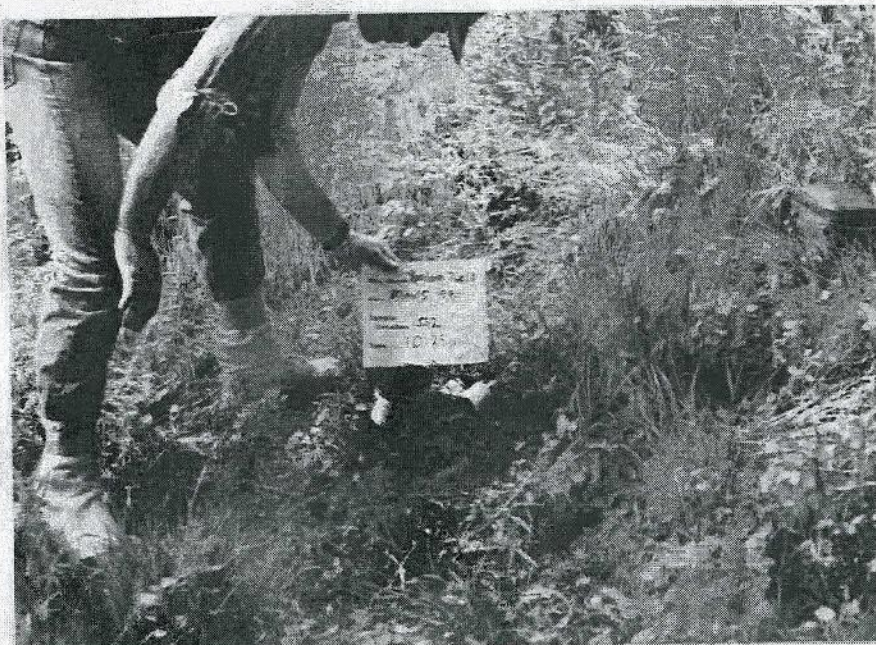
> SS2

DESCRIPTION: > Background sample at 4 foot depth from yard  
> across Spring Avenue north of siteDATE: > 5/15/90TIME: > 10:25DIRECTION OF  
PHOTOGRAPH:> northWEATHER  
CONDITIONS:> cool,> cloudy

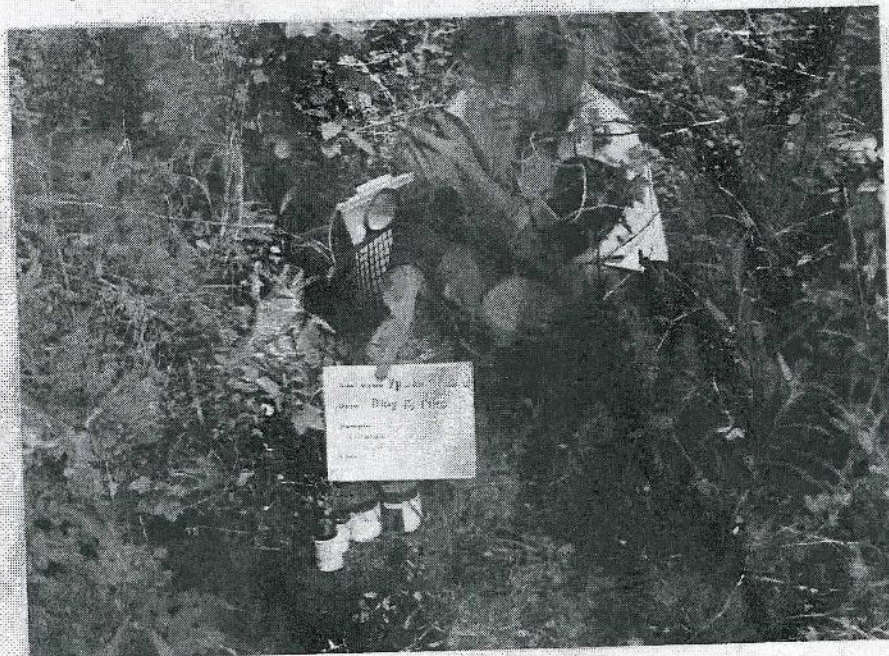
> C. FairbanksSAMPLE ID  
(if applicable):> SS3

DESCRIPTION: > Sample collected at 1 foot depth along eastern  
> edge of site, ~ 200 feet south of Spring Avenue  
> moist, marshy area.DATE: > 5/15/90TIME: > 10:40DIRECTION OF  
PHOTOGRAPH:> eastWEATHER  
CONDITIONS:> cool,> cloudy

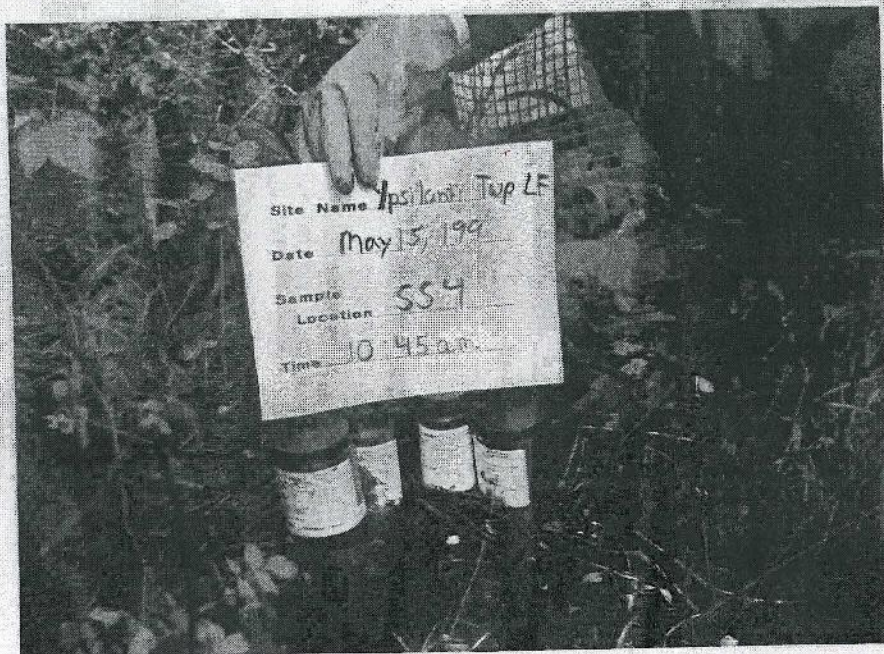
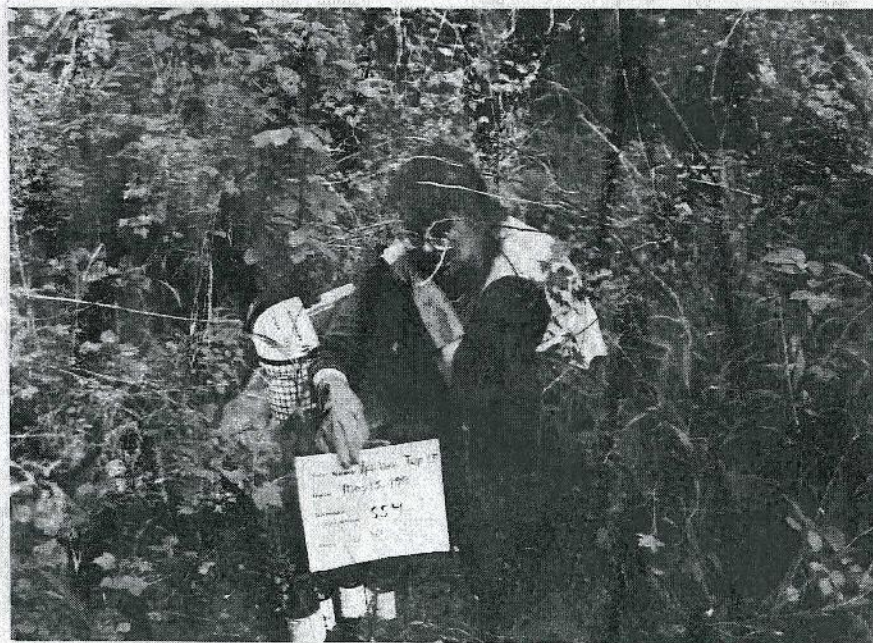
> WalczakSAMPLE ID  
(if applicable):> SS 4

DESCRIPTION: > Soil sample collected at 4 foot depth along  
> eastern edge of site ~200 feet south of Spring Avenue  
in moist, marshy areaDATE: > 5/15/90TIME: > 10:45DIRECTION OF  
PHOTOGRAPH:> eastWEATHER  
CONDITIONS:> cool,> cloudy

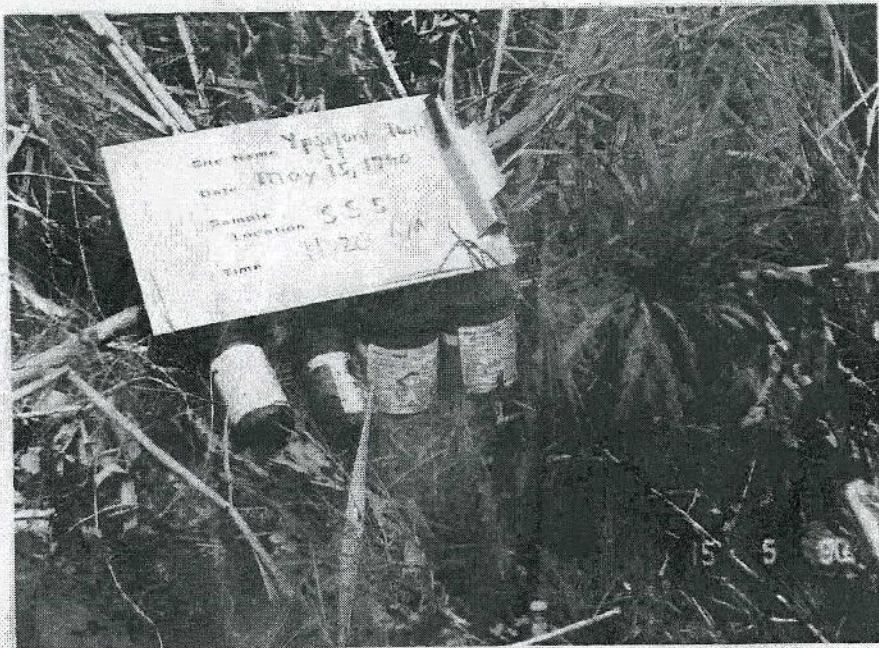
> WalczakSAMPLE ID  
(if applicable):> SS5

DESCRIPTION: > Sample collected at 1 foot depth in heavily  
> vegetative area in center of Landfill near water seepage area

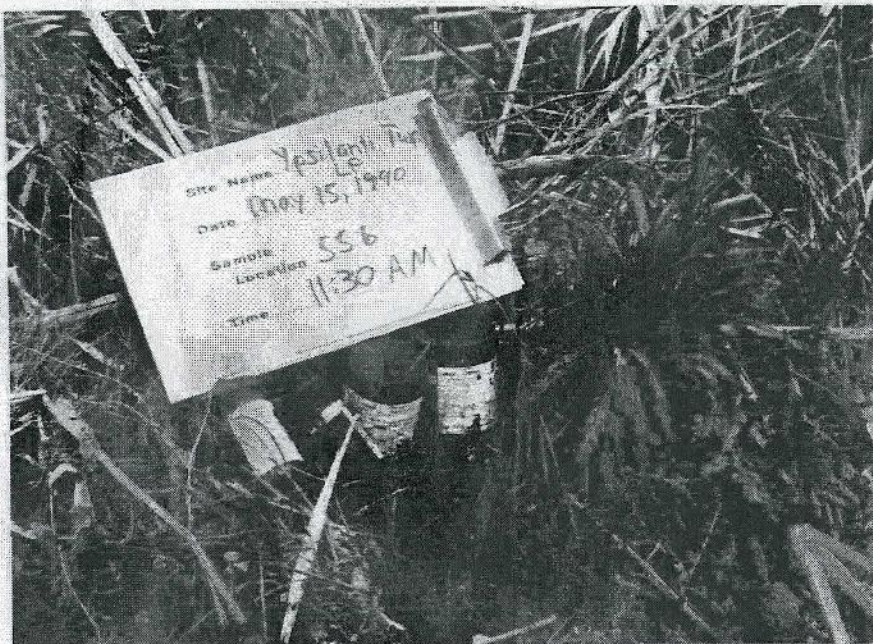
> WalczakSAMPLE ID  
(if applicable):> SS6

DESCRIPTION: > Same location as SS5 collected at 4 foot  
> depthDATE: > 5/15/90TIME: > 11:30DIRECTION OF  
PHOTOGRAPH:> SouthWEATHER  
CONDITIONS:> cool,> cloudy

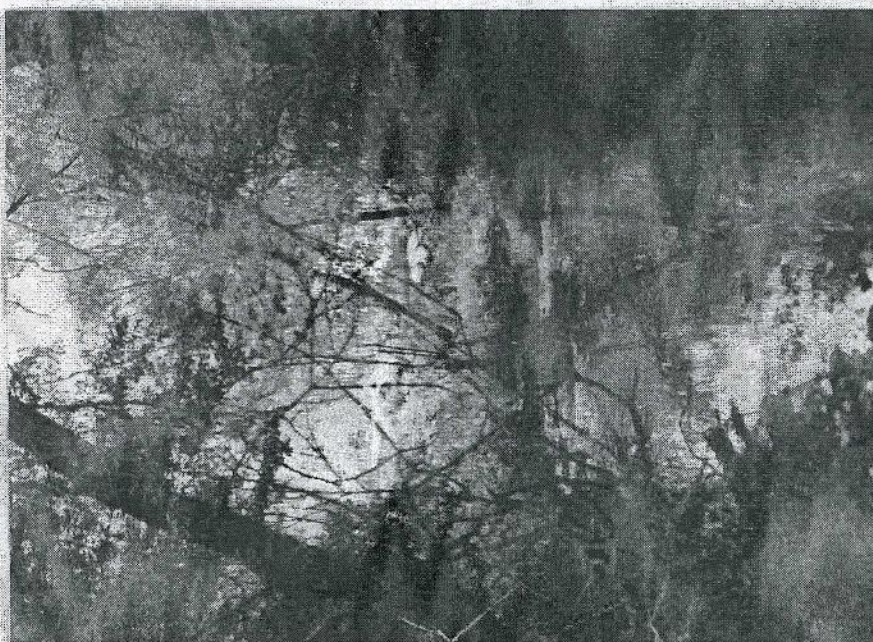
DESCRIPTION: > Looking west along drain toward area of  
> concrete chunks

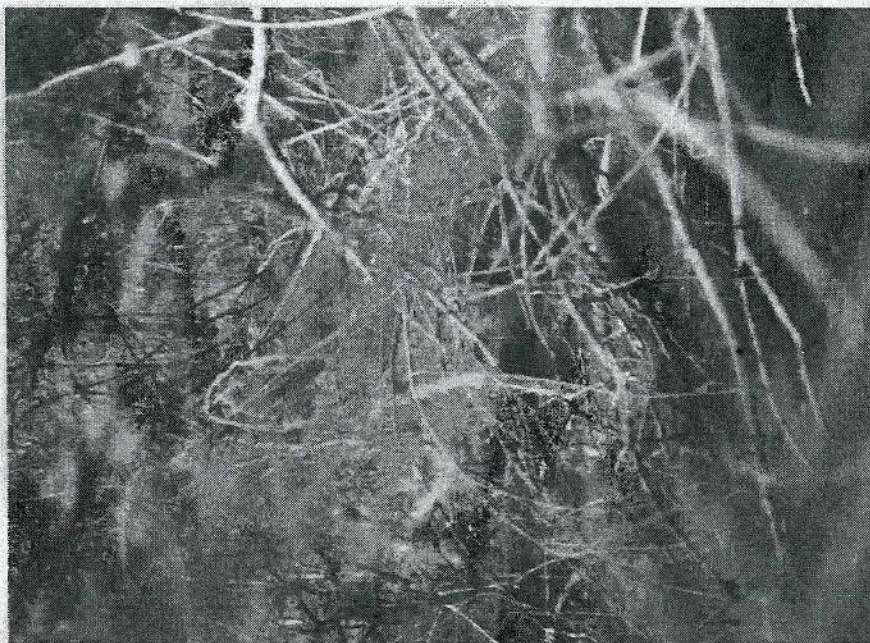
DESCRIPTION: > Refuse in drain>           DATE: > 5/15/90TIME: > ?DIRECTION OF  
PHOTOGRAPH:> NorthWEATHER  
CONDITIONS:> (cool)> Cloudy

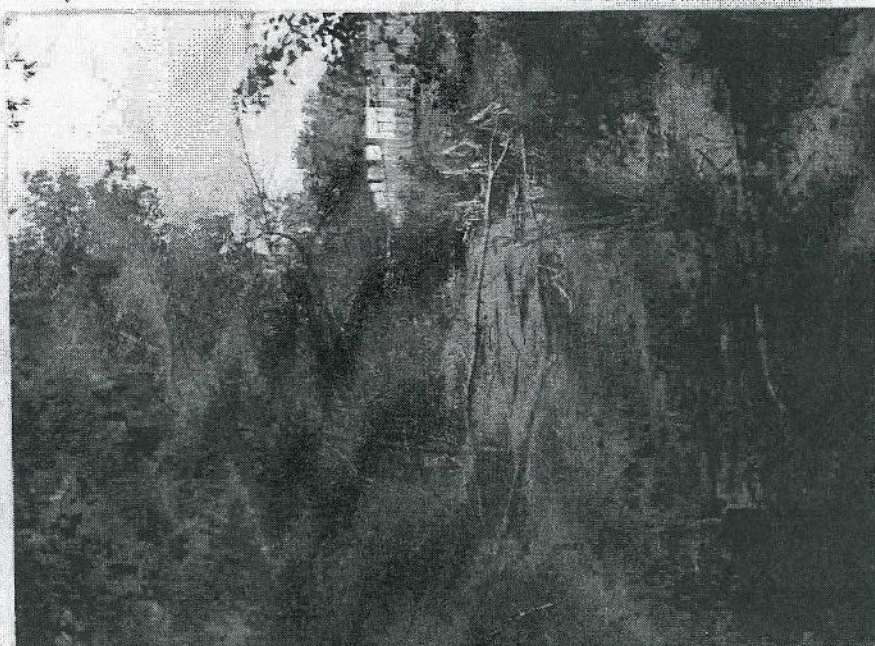
DESCRIPTION: > One fork of drain along eastern edge of Ford> Plant east of landfill

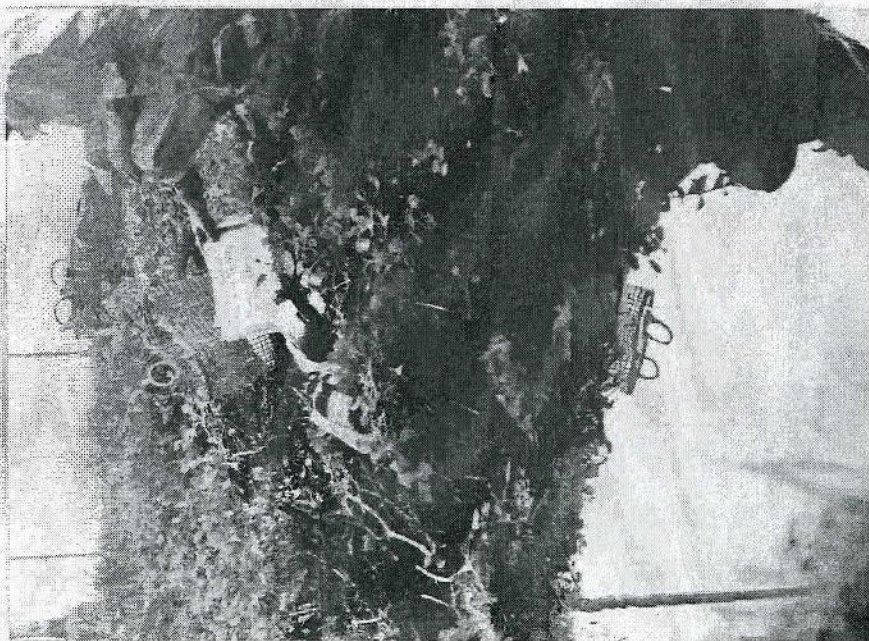
> CarpenterSAMPLE ID  
(if applicable):> SD3

DESCRIPTION: > SD3 collected in drain branch near Ford motor> Company boundary

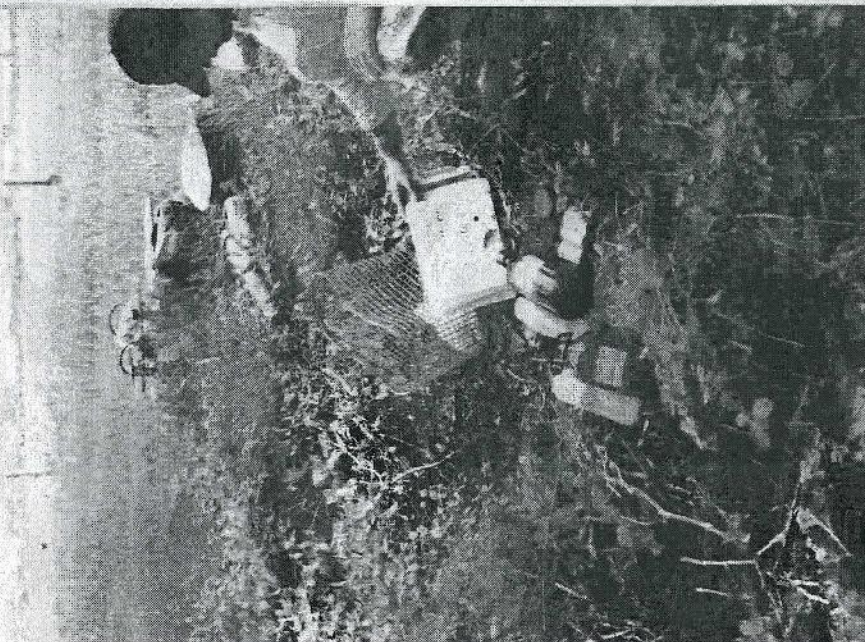
> SW3

DESCRIPTION: > SW collected in same area as SD3

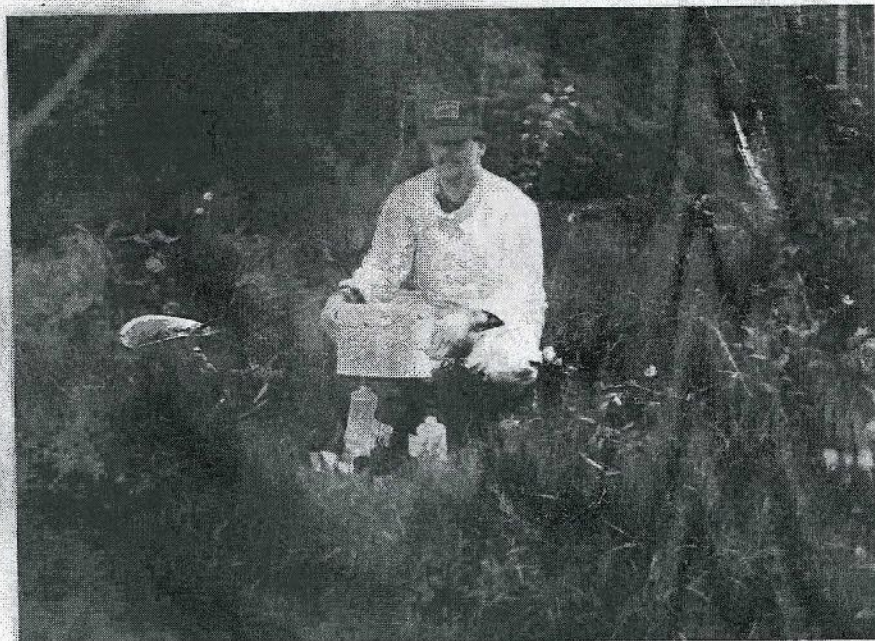
> SD2, SW2

DESCRIPTION: > Sample collected from south branch of drain  
> near eastern boundary of site.

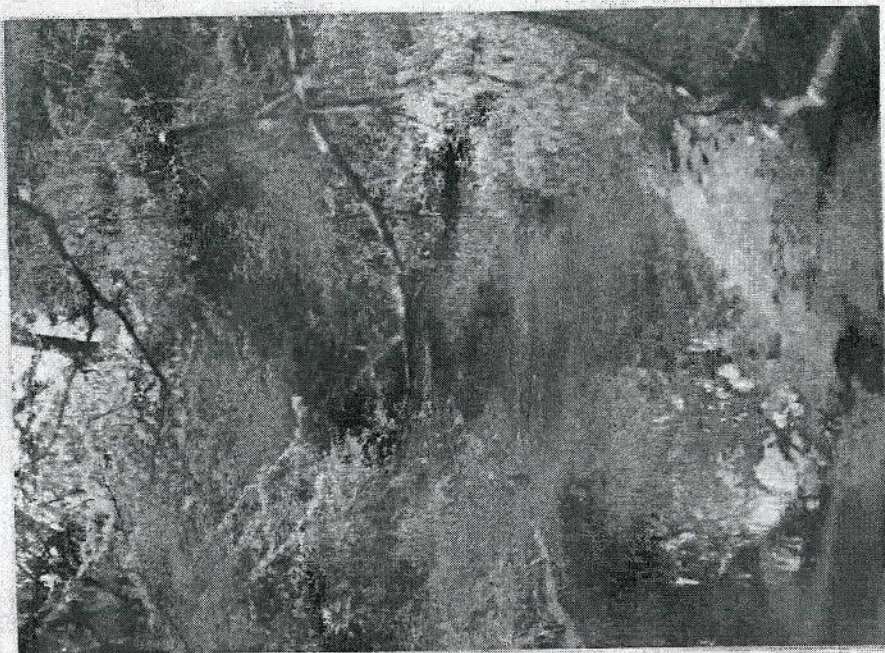
DESCRIPTION: > Drain flowing south east to Huron River>DATE: > 5/15/90TIME: > ?DIRECTION OF  
PHOTOGRAPH:> WestWEATHER  
CONDITIONS:> Cool,> Cloudy

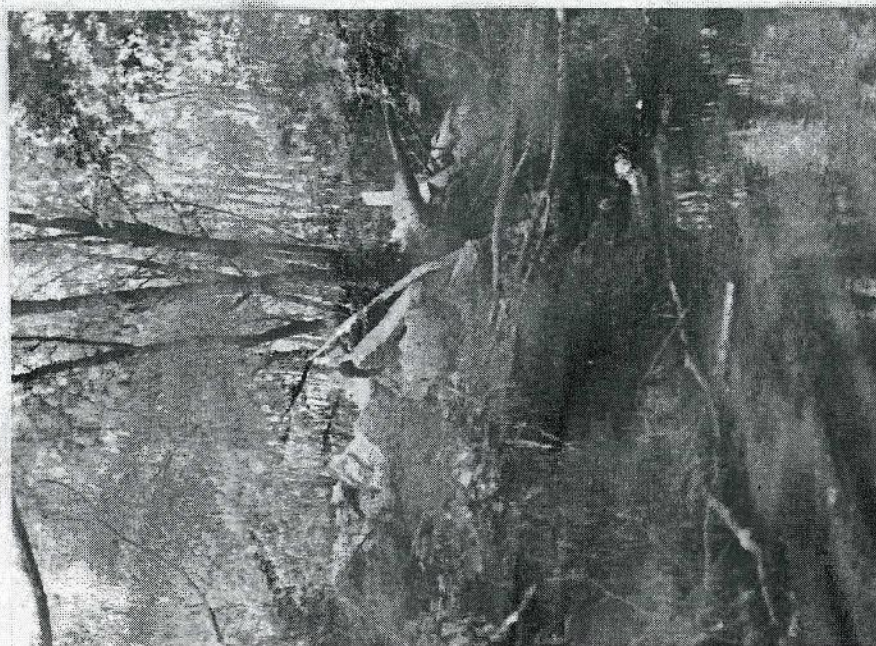
DESCRIPTION: > Scattered refuse, concrete blocks partially  
> covered by foliage.DATE: > 5/15/90TIME: > ?DIRECTION OF  
PHOTOGRAPH:> westWEATHER  
CONDITIONS:> cool> cloudy

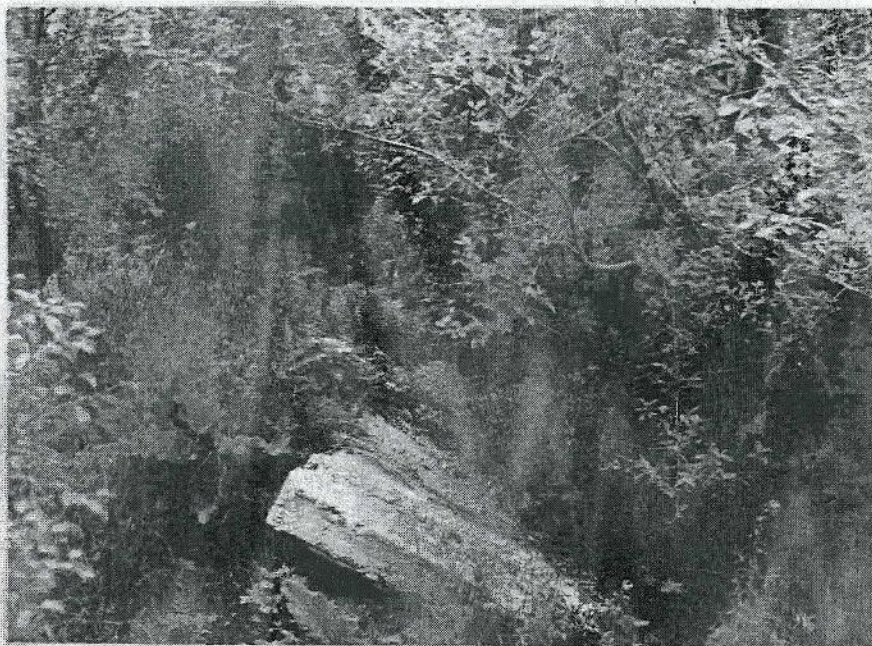
DESCRIPTION: > Concrete blocks piled near drain, middle  
> of Landfill site

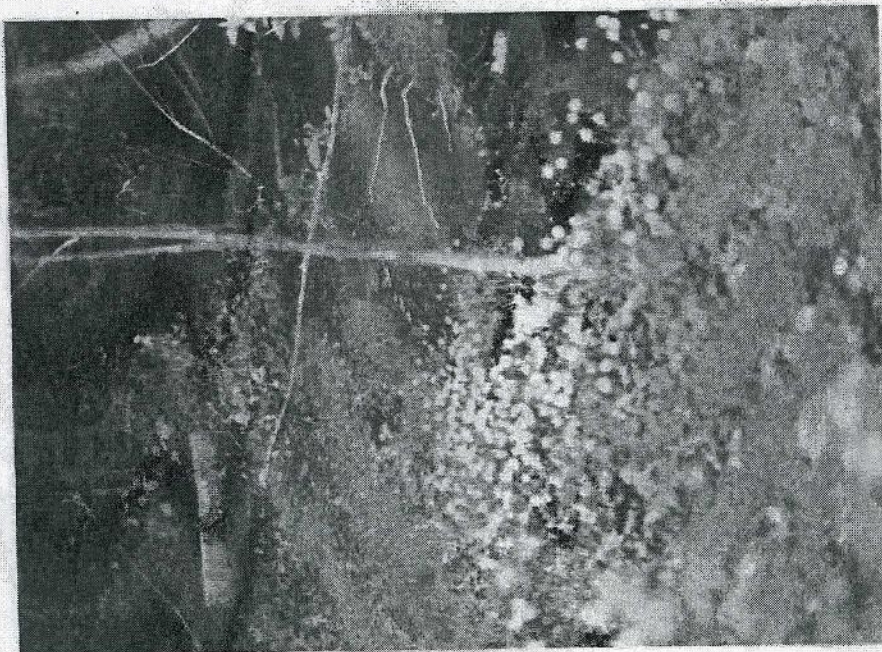
DESCRIPTION: > Refuse exposed along side drain

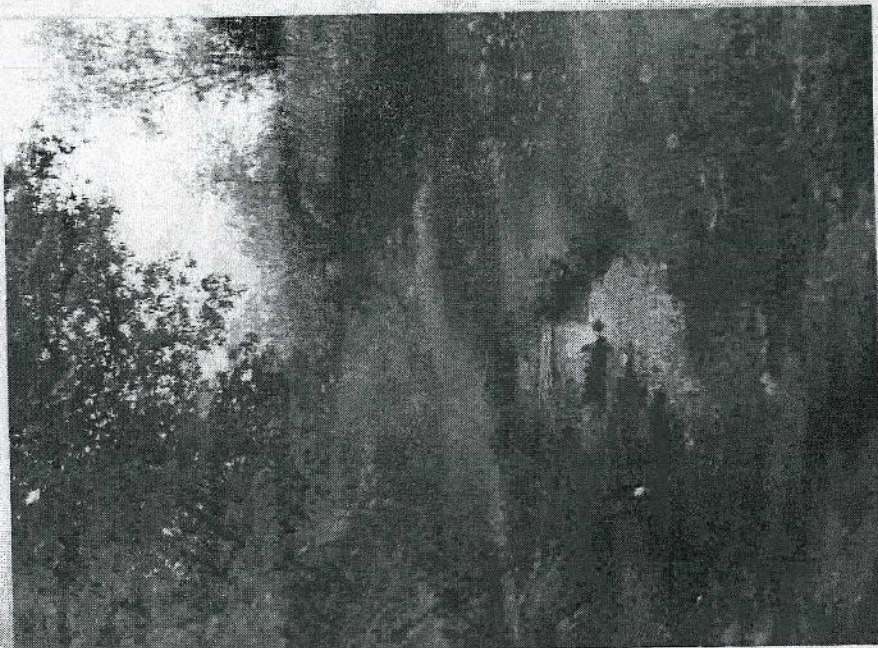
DESCRIPTION: > Refuse exposed along side drain
